Application example for the use of **Cool/BLUE®** tape wound cores from **MAGNETEC GmbH, Germany**

Damaged bearing of a pump unit due to circular currents

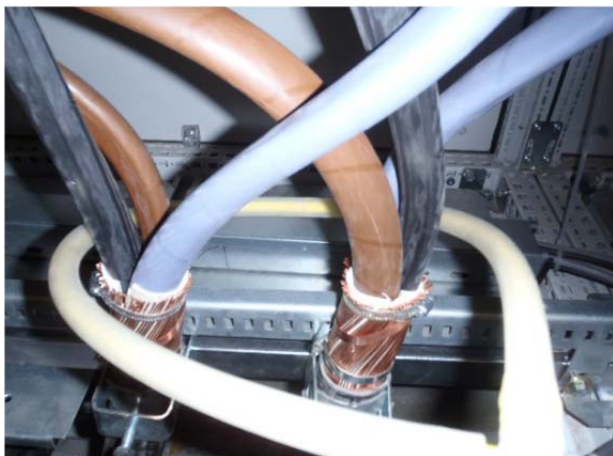
Picture 2,1: Original condition

The measurements were done before and after applying of some **Cool/BLUE®** tape wound cores from **MAGNETEC GmbH** with constant speed and without load.

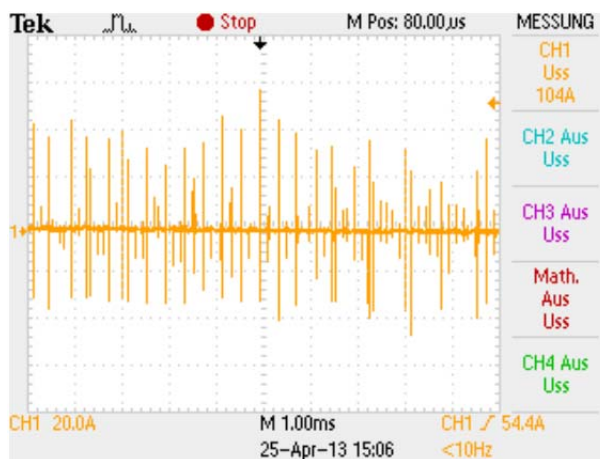
Picture 2,2: CM current at drive output
20A/Div, 1ms/Div > I_{ss} ca. **104 Amps**

Measurement 1: CM current at drive output

By using of 2 Cool/BLUE® tape wound cores M-248 from MAGNETEC GmbH per drive the peak-peak value of the CM current on the motor cable could be reduced from 104 Amps to 17 Amps – it means by factor of 6 (!)
Additionally the shaft voltage – measured as peak-peak value – could be reduced from 10 V to 5,5 V and the number of peaks were significantly lower. If an additional grounding of the shaft is accomplished the shaft voltage is further reduced to ca. 2 V, means by factor of 5 (!).

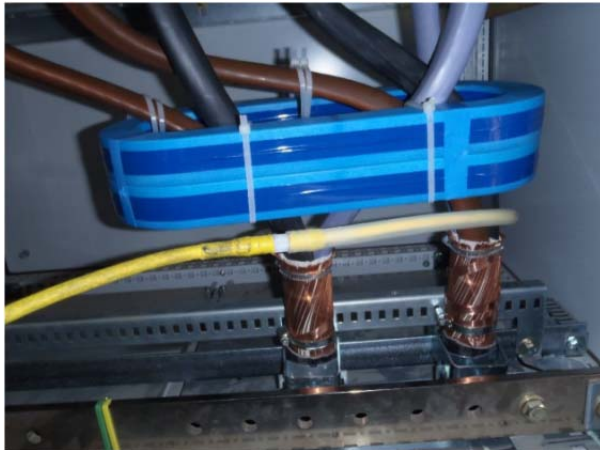
Action: Applying of 2 nanocrystalline Cool/BLUE® tape wound cores M-248

Picture 3,1: Use of 2 cores M-248

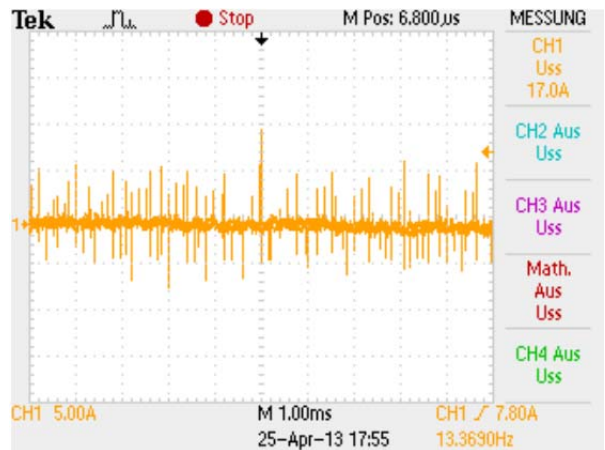
Picture 3,2: 5A/Div, 1ms/Div > Uss ca. **17 Amps**

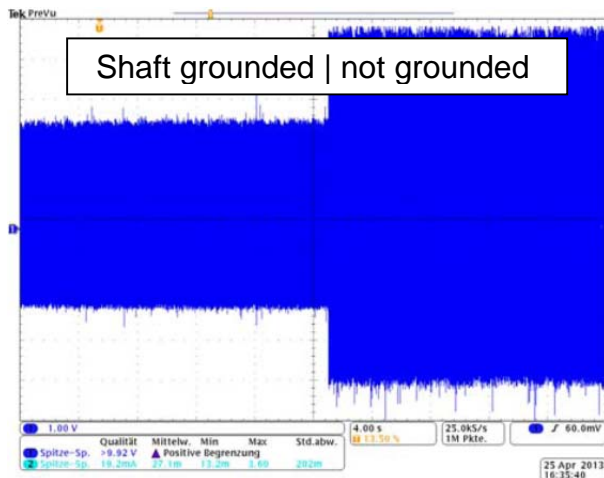
Measurement 2: Shaft voltage

Picture 4: Original condition
1V/Div > Uss max ca. **10 V**

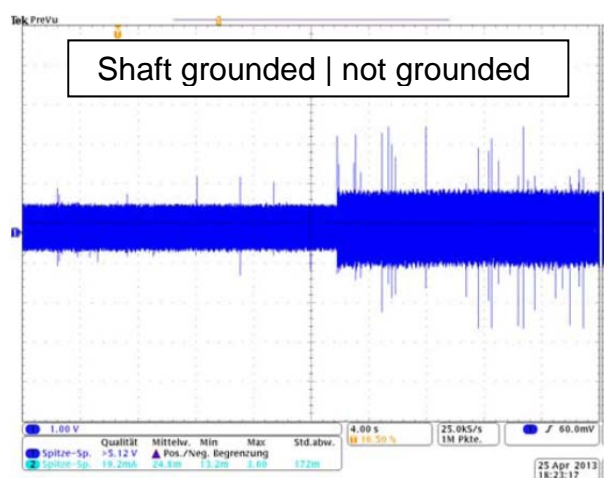
Picture 5: Use of 2 cores M-248
1V/Div > Uss ca. **5,5 V**
